Historic Resources Report

SOUTHERN WATERFRONT

SAN FRANCISCO, CALIFORNIA

December 1994

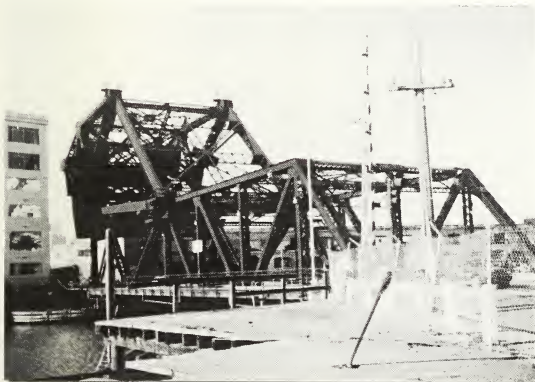
This is a Heel-Trunnion drawbridge which opened May 12, 1933. The bridge is notable for its 140 foot long, riveted steel, single leaf bascule truss in the main span. The entire structure is supported on a concrete substructure resting on driven timber piles. The prominent concrete counterbalance weights are suspended at the northern approach above the roadway. The structure appears to be in good condition.

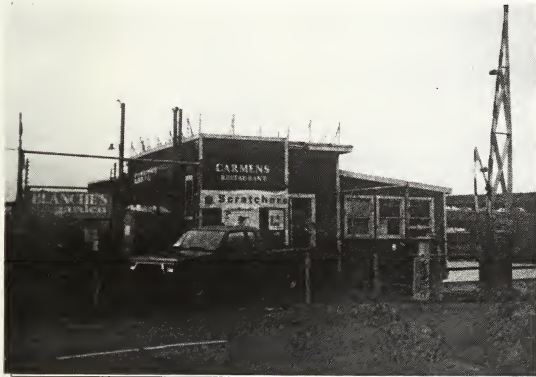
This small single-story rectangular wood-frame building extends along Mission Creek on Pier 60. It is flat roofed, has double-hung wood windows and is clad in horizontal drop siding. The building extends towards the creek with a shed-roofed addition, and is bordered on the west (rear) by a pier-top garden. It is in good condition.

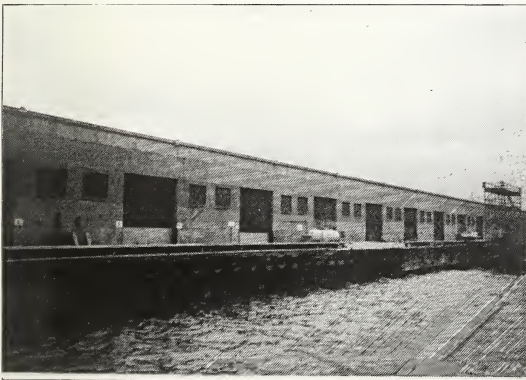
These sheds are constructed of reinforced concrete with a steel-truss-supported roof. These long narrow buildings rest on piers supported by timber pilings. Two rectangular steel sash windows alternate with one large rolling metal door across the entire length of the buildings. These structures appear to be in good condition.

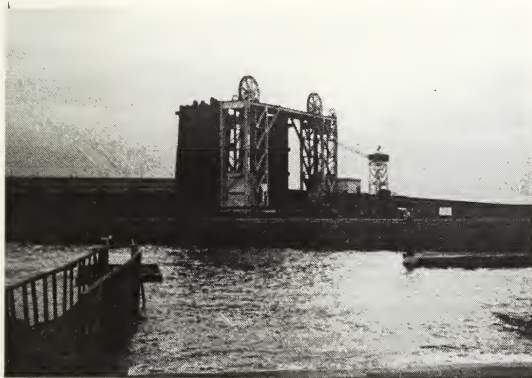
This freight tower assembly consists of two metal truss towers each topped by a single large pulley wheel. The towers, connected by several cross beams, straddle double tracks on a ramp resting on a wooden pier. Vertical tower-height timber poles extend to the north of each tower.

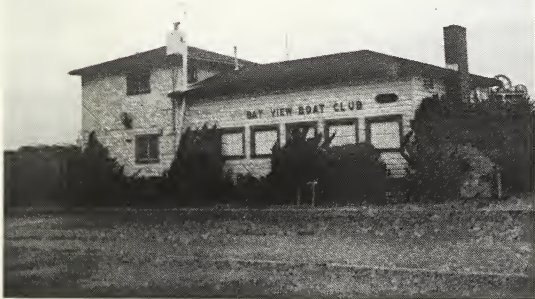
This is a small rectangular wood-frame building with a hipped roof. The north section is two stories. Cladding at the first level is horizontal drop siding, while at the upper level it is narrow clapboard. The one story section has closely-spaced multi-lite wood windows, painted over. The two story wing has both wood and aluminum replacement windows. Each wing has a masonry chimney extending above the roof. A wood deck extends back from the building. The structure is in fair to good condition.

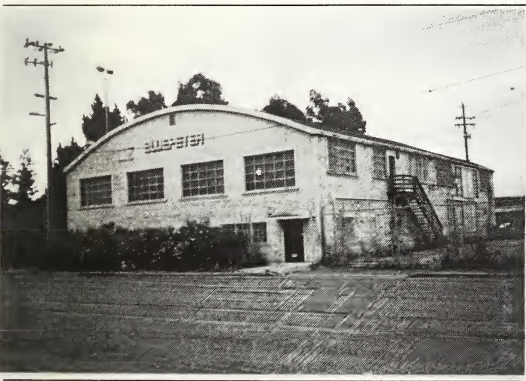
Dominated by a vaulted roof, this is a two-story, rectangular, wood-frame industrial building. Cladding is flat horizontal wood siding. Windows are fixed, multi-lite wood units, regularly spaced on the front, Illinois Street facade. The ground floor, smaller windows are covered with metal security bars. A single door provides Illinois Street access. The long south elevation has additional wood windows, a second level exit door, and an exterior wood staircase. Additional double doors are located on this same elevation.

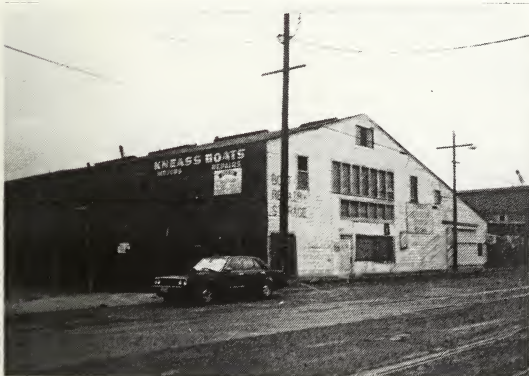
P1. Resource Identifier: Boat Repair Storage

This large, two-and-one-half story saltbox-shaped warehouse is of wood-frame construction and is clad in horizontal drop siding. Most of the wood window openings are covered with either plywood or corrugated fiberglass panels. Skylight openings are visible on the roof. Signage on the north elevation reads "Kneass Boats." Illinois Street access includes both a single, wood man-door and a large sliding wood loading door. The structure is in fair condition.

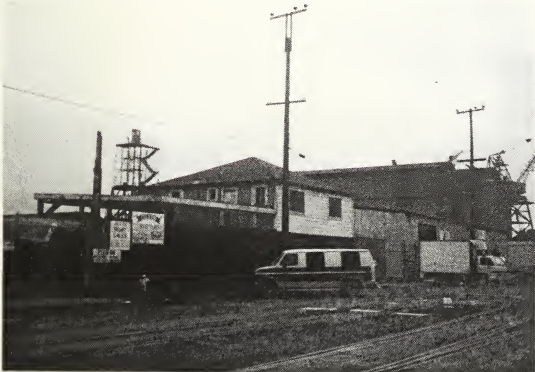
This is a small, square, wood-frame building with a pyramidal roof. It is two stories, clad with horizontal drop siding, and glazed with an assortment of windows. Some windows are wood and others are aluminum replacements. Additions extend to the rear. The structure is in fair condition.

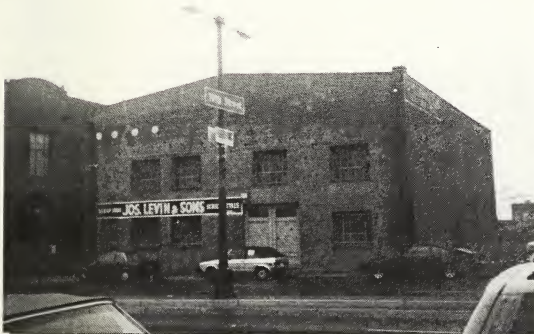
This square, two-story warehouse faces Third Street. Windows are square, steel sash units with metal security grates on the first floor. The low-pitched gable roof is hidden behind a similarly low-pitched brick parapet, with a soldier course of brick inset at the cornice line. This same brick treatment is used in the course directly above the windows, differentiating them from the common-bond brickwork found elsewhere. Four tie rod bolts extend through the northwest corner of the front elevation. Transomed, double, wood entry doors are faced with diagonal bead boards. The structure is in good condition.

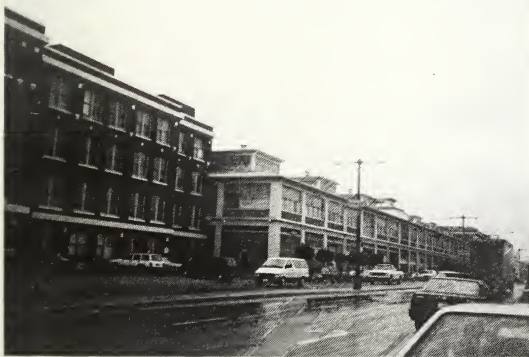
The flat-roofed administration building is set back from the street and semi-attached to the southern factory wing. Textured brick is the primary cladding with a concrete belt course above the ground floor and at the cornice level. The central entry is located within a small projecting square bay topped with a flagpole. The wood double-hung windows are grouped in pairs except in the center where they are arranged singly. The integrated ornament is found between fourth story windows and consists of flush, square, light-colored inserts and patterned brick rectangular drops ending in projecting telescoping concrete rectangles. These relate to similar tiled motifs on the adjacent factory sections of the building. (continued on next page)

After a mid-block, stripped down, two-story section, the southern portion is four stories tall with a projecting, bracketed brick-and-stucco cornice. End bays have low-pitched, gabled parapets, with square, stucco inserts. This motif is repeated on the brick spandrels between the third and fourth floors. This southern end may have been built before the northern end.

The entire complex appears to be in good condition.

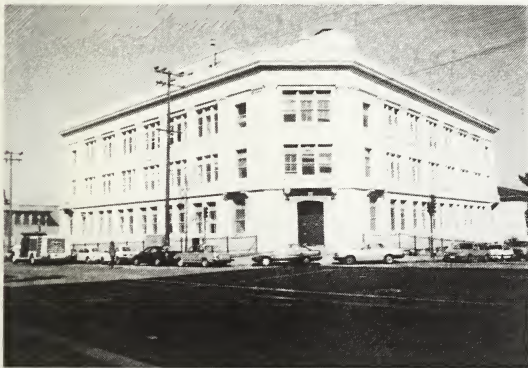
This is a classically-detailed "L"-shaped, flat-roofed three-story with basement building. It is clad with stucco, with double-hung wood windows and a corner front entrance. The primary facades are ornamentally rich. Rusticated stucco enriches the first floor facades, with granite steps and a cast ornamental surround at the entry. Windows here are paired. Between the first and second floor is a wide string course, with projecting balconies above the entry and at both end bays of the 20th Street and Illinois Street facades. Two-story fluted Doric pilasters ascend from the string course, dividing the primary facades into bays. Set within each bay, windows are in groups of three, with cast ornamental spandrel panels between the second and third floors. A wide, simple entablature tops the building, with a projecting cornice band and solid parapet. The building appears to be in good condition.

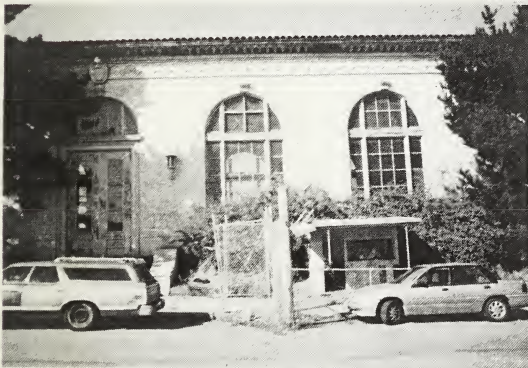
This tall, one-story rectangular building, with hipped, ceramic tile roof, was designed by San Francisco architect Charles Peter Weeks. The front (20th Street), and rear facades are each five bays wide, with one-bay-wide end facades. Five large, arched openings dominate the primary facade. The center, cartouche-topped arch contains the entry doors, which are paneled, and clad with galvanized metal. The remaining arches contain multi-pane wood windows with operable transoms. The building's entablature is notable for its terra cotta shell motif frieze and copper modillioned cornice. The building's interior, visible through the large openings, appears to contain most, if not all, of its original equipment. This building appears to be in good condition, except for the cornice, which is in poor condition.

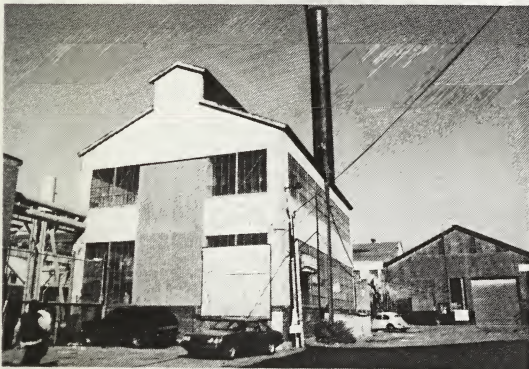
This is a two-story rectangular metal building, with a gabled monitor roof. Typical of many of the metal buildings at the Yard, the structure has a brick-clad base, with corrugated steel cladding and roofing, and steel sash windows. A black-painted steel smokestack ascends from the southeast corner. The building appears to be in good condition.

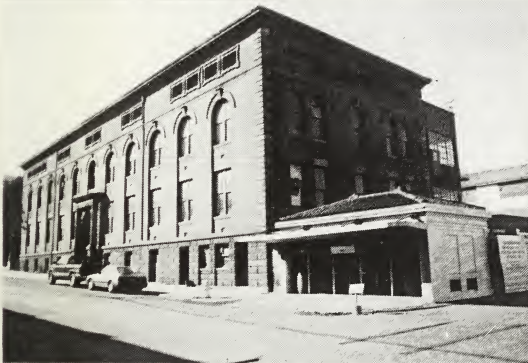
This red-brick, Renaissance-inspired building is two stories high with a full basement and attic. It has a hipped, clay tile roof and wood, double-hung windows. Originally "T"-shaped, with the primary rectangular mass on 20th street and a projecting center bay at the rear, the rear void areas have since been infilled to create a rectangular foot print. Two-story-tall brick arches, each containing paired, first and second story windows, dominate the front (20th Street) and two side facades. These arches are set above a rock-faced, rusticated, concrete basement and sandstone waterable. Sandstone also accents the building as quoins, keystones and window sills, an upper-level string course and the building entry. This finely-detailed Renaissance portico features banded rustication, engaged Ionic columns and a projecting cornice over and arched opening. The entry recess features a coffered, barrel-vaulted ceiling and polished marble walls. A sandstone string course separates the second floor from the attic. Deeply set, paired, rectangular windows, with shouldered, molded brick and terra cotta surrounds, punctuate this level. A copper modillioned cornice, in poor condition, tops the building.

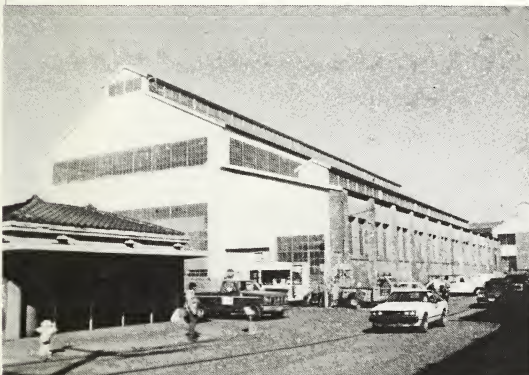
This tall two-to-three story rectangular metal warehouse building has a gabled, monitor roof. A one-story shed-roofed projection, with its own roof monitor, abuts 20th Street. This steel-framed industrial building has corrugated metal cladding and steel sash windows. The 20th Street facade is brick clad, with projecting brick piers, echoing the nineteenth century brick warehouse across the street. The remaining elevations rest on a five-foot high brick base. The building appears to be in good condition.

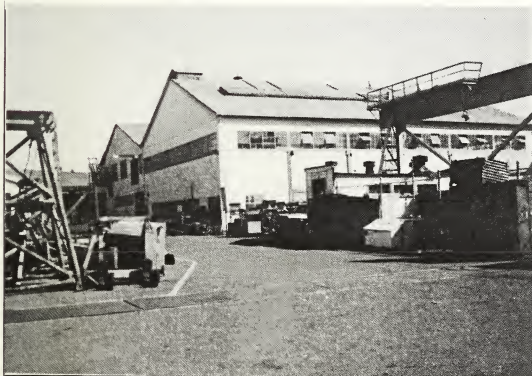
One of the oldest extant buildings in the yard, this is a two-story, double gable, metal-clad building. Possibly built in two phases, the western portion is taller, with horizontal strip, fixed and awning steel sash windows. Covered skylights are visible on the roof. The eastern portion has individual double-hung windows and a second story loading door with crane. This eastern mass appears to be earlier than the western, however, the steel sash strip windows on the western half of the building, as well as the corrugated metal cladding, may be modifications. Wooden rafter ends are visible at the gable-end eaves. The building appears to be in fair to good condition.

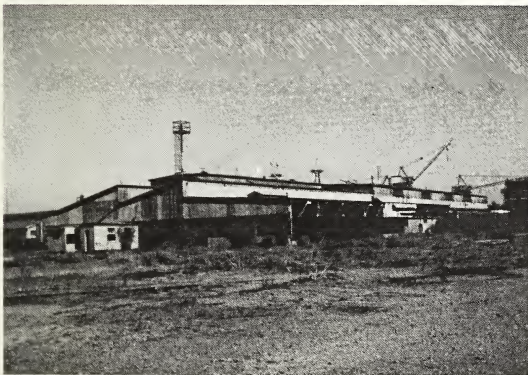
This is a 480' long, one-story metal warehouse, essentially rectangular, with a slight "L" at the eastern end. It is clad with corrugated metal and has steel sash windows. The building has an irregular roof line. At the eastern end, it forms a double sawtooth, with a shed roof over the "L" extension. The western end has a flat roof with several wide, glazed monitors that run the width of the building. This feature appears to relate to the building's function as a "plate shop," since a second such structure, "Plate Shop #2," has a similar roof profile. The building appears to be in fair to good condition.

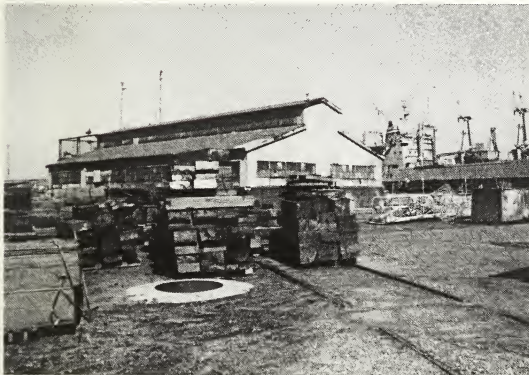
This is a rectangular, 85' long, 46' wide, 24' high metal building with a gabled monitor roof. It has corrugated metal siding and roofing, set above five foot high brick walls. The horizontal strip windows are steel sash with operable awning panels. The building appears to be in fair to good condition.

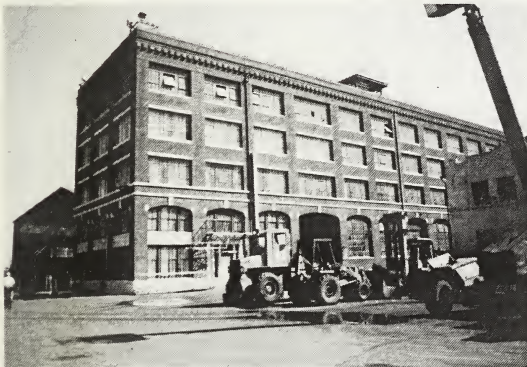
This four story, rectangular, finely-detailed brick building has a flat roof and extensive glazing. The first floor is high, and topped by a wide, cast belt course. Openings on this floor have arched heads, with terra cotta keystones and imposts. At the northern end of the structure, a mezzanine creates a second story. This area appears to be designed as office space, with wood, two-over-two double-hung windows and paneled spandrel panels between the two levels. At the southern end, the arched window openings contain steel sash panels with some operable awning sash. The three floors above are uniforms, with wide rectangular steel sash windows. An arcaded cornice tops the building. The brickwork on this building is of very high quality. In addition to the cornice detailing, header courses run vertically up both sides of each pier. Rowlock courses run at toe top of each window. Diagonally placed bricks form diamonds, centered in each spandrel panel at the third and fourth floor level. The building appears to be in excellent condition.

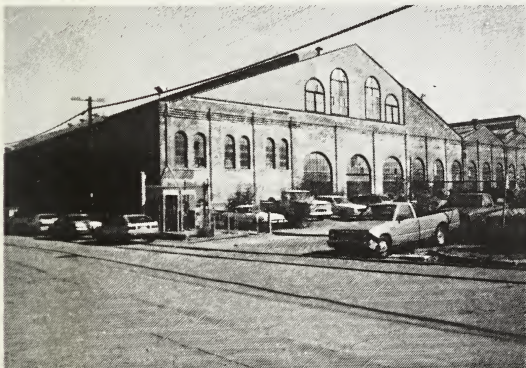
This 450 foot long structure consists of two original brick structures, dating from 1886, connected by a c. 1914 reinforced concrete infill structure. Both brick structures have gable roofs, projecting piers, arched windows and simple corbeled cornices. The western structure, the original machine shop, consists of one wide (nine-bay) gable and two three-bay gables. Windows are steel sash, with both large, single arches filling the bays and, on 20th street, smaller arched windows in groups of three. The eastern structure is a single gable wide, and originally housed the bolt and rivet shop and the erecting shop. Detailed similarly to the western portion of the building, this portion has large, single-arch-per-by metal sash windows. The connecting structure is similar to the steam powerhouse across the street, with which it is roughly contemporary. It is classically detailed, with a large, arched center opening and flanking steel sash windows. Cast cartouche ornaments top each of the four piers, and a dentilated cornice tops the structure. This structure appears to be in good condition.

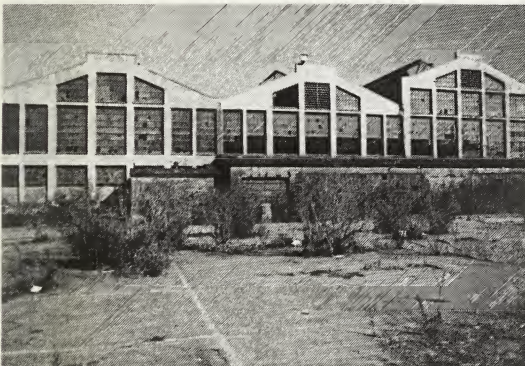
These reinforced concrete warehouse structures have a strong, industrial-modernist aesthetic, characterized by expressed structure, with expansive steel sash window infill. The gable roofs have squared parapets at the gable tops. Beneath two of the gables are ventilation grilles. Monitor skylights are visible on the roof. On the west facade, the words "Pacific Coast Steel Corporation" are painted on the center gable. A corrugated metal shed-roofed addition abuts the south end of the building on the west side. The building is in fair condition, with many broken or missing windows.

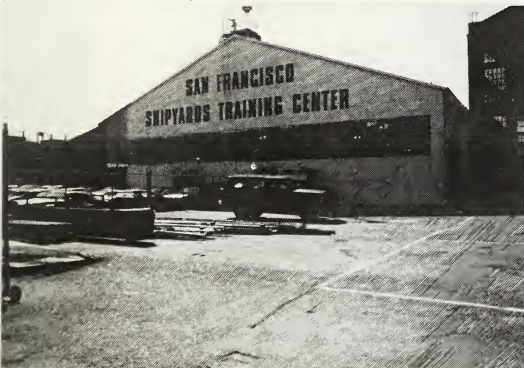
This is a wide, one-story gable-roofed structure with corrugated galvanized iron siding and steel sash windows. Painted signage on the eastern gable end reads "San Francisco Shipyards Training Center." The building appears to be in good condition.

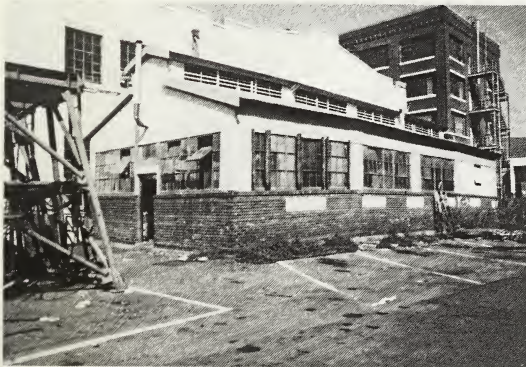
This one-story metal building is 60' long by 24' wide by 19' high. It has a gable, truss-supported roof with monitor. Cladding is corrugated steel over 5' high brick walls, with a corrugated steel roof. Windows are steel sash, with ventilation grilles in the raised monitor. The building appears to be in good condition.

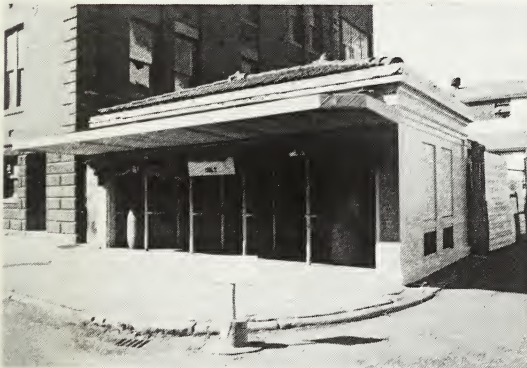
This small wood and concrete structure is 25' long by 16' wide by 16'-8" high. It has a ceramic tile hipped roof and a wide, marquis-type overhang on the south, 20th Street facade. A similar overhang once protected the north facade; however, this elevation is now enclosed. A similar structure once stood at the opposite side of the gate. This building appears to be in good condition.

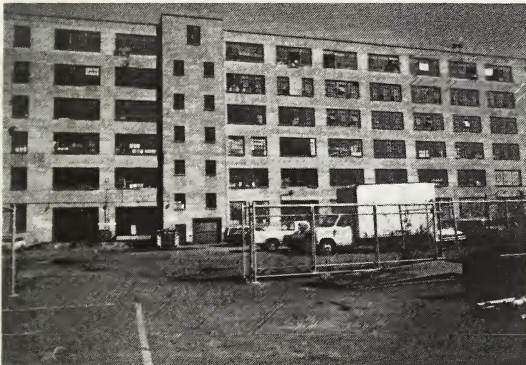
This six-story concrete warehouse is rectangular, with a flat roof. The building is 256' long, 76'-9" wide and 79'-6" high. The large windows are multi-pane steel sash. An elevator and stair tower projects slightly from the west facade. This building appears to be in good condition.

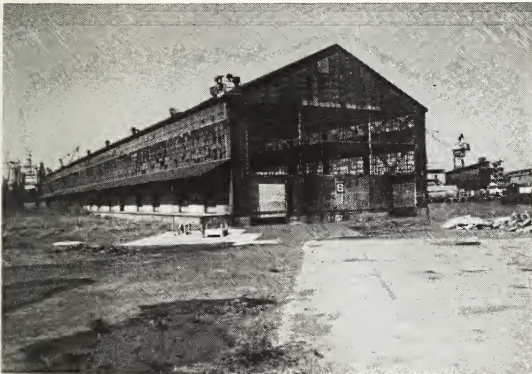
This is a massive, 512' long, 72' wide, 52' tall metal warehouse with a covered loading dock on its west side. It has corrugated steel siding and roofing, steel sash windows, and a large, rolling metal door on its north end. The concrete floor slab rests on creosote-treated, 12" diameter Douglas fir piles. The building appears to be in fair condition.

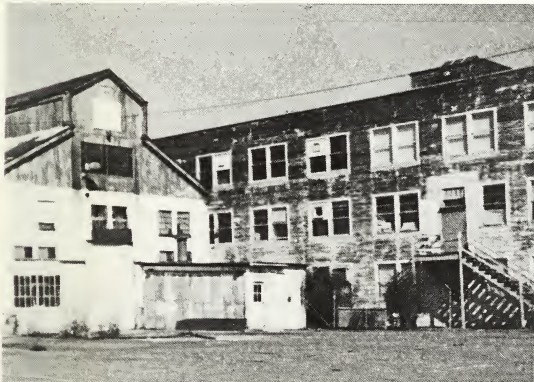
This three-story rectangular wood frame structure is 156' long by 72' wide by 38' high. It has a flat tar and gravel roof, wood double-hung windows grouped in pairs, and is clad in horizontal wood siding. There are exterior stairs on the west elevation. Two stair towers project one story above the roof. The building appears to be in fair to good condition.

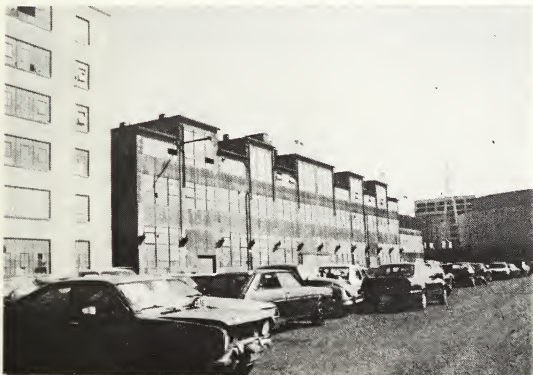
This square, steel and wood building is two stories tall. It is 248' wide and 59'-6" tall. The roof line is irregular, with five raised, glazed monitors running the width of the building. The building is glazed with large steel sash windows. The building appears to be in fair to good condition.

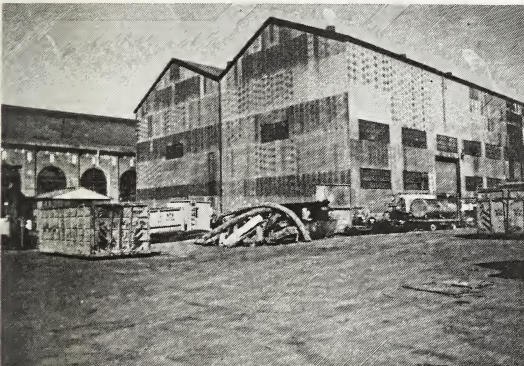
This is a large, double-gable metal warehouse. Cladding consists of corrugated, galvanized iron siding. The building has steel sash windows and a rolling metal door. The building appears to be in fair to good condition.

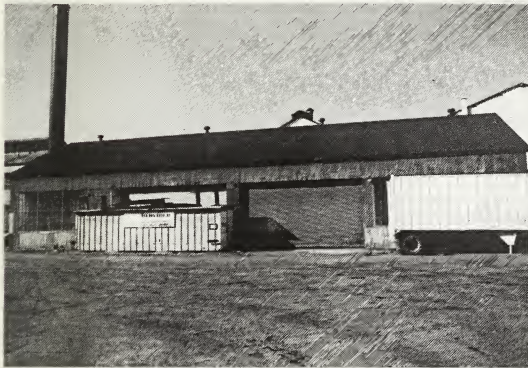
This is a one-story rectangular metal building with a gable roof. Roofing and siding is corrugated galvanized iron. The building has steel sash windows and large rolling metal garage doors.

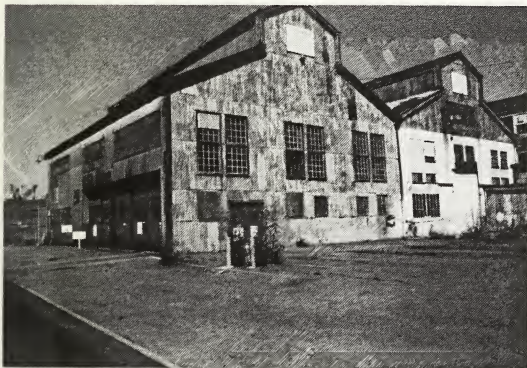
This two-story double-gable metal building is 101' long by 75' wide by 44' high. Each gable has a wide roof monitor. The building is clad with corrugated iron, and glazed with double hung wood and horizontal steel sash windows. The building appears to be in fair to good condition.

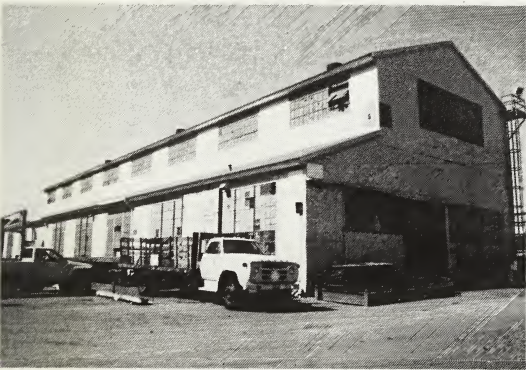
This metal building is 200' long by 60'-9" wide by 47' high. It has a gable, steel truss-supported roof and a 17'-9" high shed-roofed area on its north side. Cladding and roofing is corrugated, galvanized iron. Windows are multi-paned steel sash, with operable awning panels. The building appears to be in good condition.

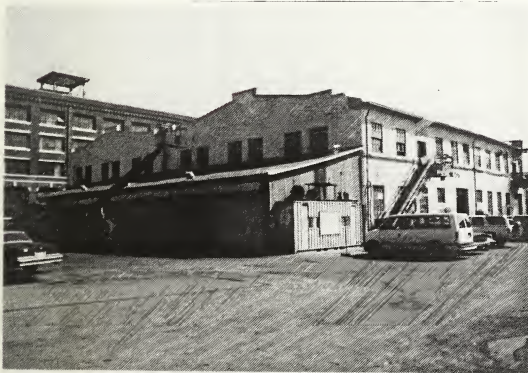
This square-plan, reinforced concrete structure is two stories high, with a double gable, geometrically-shaped parapet. Windows are steel, multi-pane, double-hung and awning sash. A one-story metal shed addition covers the north facade. The building appears to be in fair to good condition.

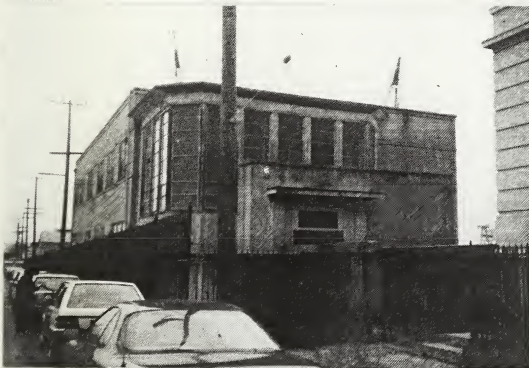
This is a Bauhaus-inspired, four-story rectangular structure with a flat roof and two-story, glazed entry feature. The building stands adjacent to a retaining wall at Illinois Avenue, with two stories above street level at Illinois Avenue, and the main entry at the third floor. The building entry is approached by a bridge from Illinois Avenue, flanked by plain, six-foot high stucco walls. The door is now plywood-covered, but appears to have been a double entry door with transom above. The door surround is faceted, with a simple, projecting overhang above. A glazed, two-story, bevel-corner stairhall stands behind the entry door, dominating the facade. Horizontal-paned, vertical wood window sash form the cladding of this stairhall. The body of the building, extending north from the entry, is a simple, stucco-clad, rectangular block. The double hung windows are arranged in groups of two or three, with simple, horizontal bands of scored stucco relief. The building appears to be in fair condition.

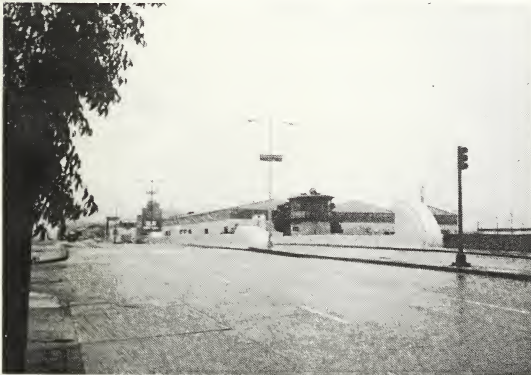
The small, two-story, elliptical bridge control house on the northeast side is constructed of concrete, green glass, and copper. The lower story is solid concrete except for a small horizontal strip window. A projecting porch surrounds the second story, which features angled, green glass windows and a flat roof topped by a large light fixture. This structure appears to be in good condition.

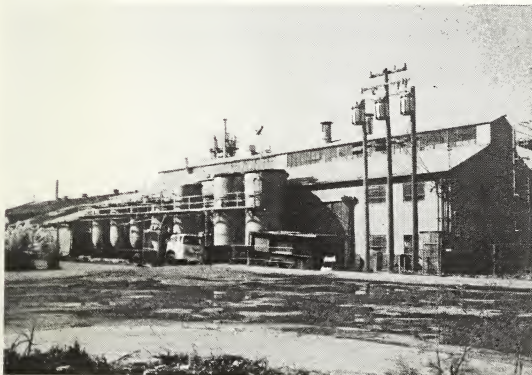
This large rectangular metal warehouse is topped by a gable roof with a full-length glazed monitor. The siding and the roof are unpainted corrugated metal and the windows, including the continuous monitor clerestory, are steel sash. The building features prominent storage bins on the west side. A series of concrete storage silos are located to the north. South of this building is a one story metal building, with a metal clad gable roof. A small, square, two story, gable roofed metal building stands to the north. This building appears to be in fair condition.

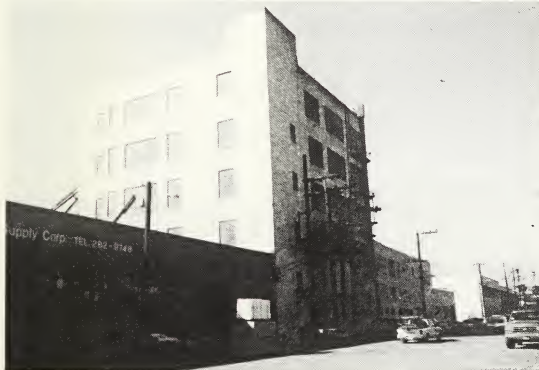
This is a five story, square, flat-roofed concrete warehouse. Windows are steel sash, with some operable awning panels. A taller, slightly projecting corner on the north, probably an elevator tower, has small single windows. A fire escape is attached to the north elevation. The flat unadorned exterior has signage on the west elevation reading "C.E Grosjean Rice Milling Co. Growers California Rice Millers. The building appears to be in good condition.

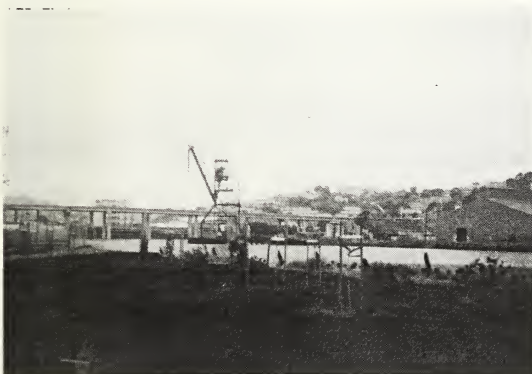
A prominent feature in the immediate area, this open structural steel loading tower stands approximately four to five stories tall. The broader base stabilizes the tall projecting arm. This tower is adjacent to pier 84, and no longer in use. The structure appears to be in good condition.

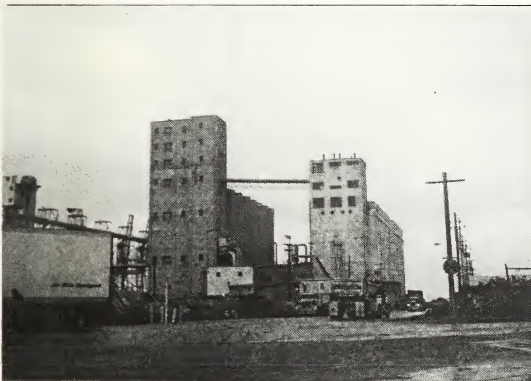
The northern structure features a similar, approximately 130' concrete tower block, with steel sash windows predominately in the top section. Extending east is a cluster of 21 attached concrete cylinders. Atop this northern, taller tower block, at the flat roof, a hoist is mounted with cables hanging near the larger loading openings. To the north of both buildings is a series of steel conveying platforms, supported on skeletal steel towers, each with stair access. The structures appear to be in good condition.

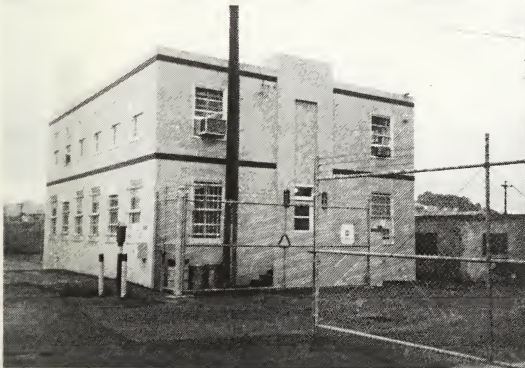
This small, square, two-story office building is located west across a parking lot from the grain elevators. Constructed of wood-frame and finished with stucco, it has a flat roof hidden behind a parapet. Windows are regularly spaced, double hung (2/2) wood with horizontal muntins. The entrance, on the east elevation, consists of a slightly raised and projecting bay with a single wood door with a transom above. A shallow, unadorned recess is above the door. Two five-inch-wide bands constructed of four, half-round wooden strips adorn and encircle the building at the second story and roofline. The structure appears to be in good condition.
